A Red Light Running (RLR) Photo Enforcement System was installed at the intersection of US Rte. 6 (159<sup>th</sup> Street) at Kedzie Avenue on January 19, 2009 (westbound) and January 24, 2009 (eastbound), after finding limited success with other attempted measures to promote safer driving and improve compliance with traffic laws. As a condition of use, both Illinois law and the Illinois Department of Transportation require periodic statistical analyses/evaluations be conducted.

**US Rte. 6 (159<sup>th</sup> Street) at Kedzie Avenue**  
**Markham, IL**

- RLR Photo Enforcement System monitors violations occurring on the eastbound and westbound approaches of the intersection
- RLR Photo Enforcement System installed: January 19, 2009 (westbound) and January 24, 2009 (eastbound)

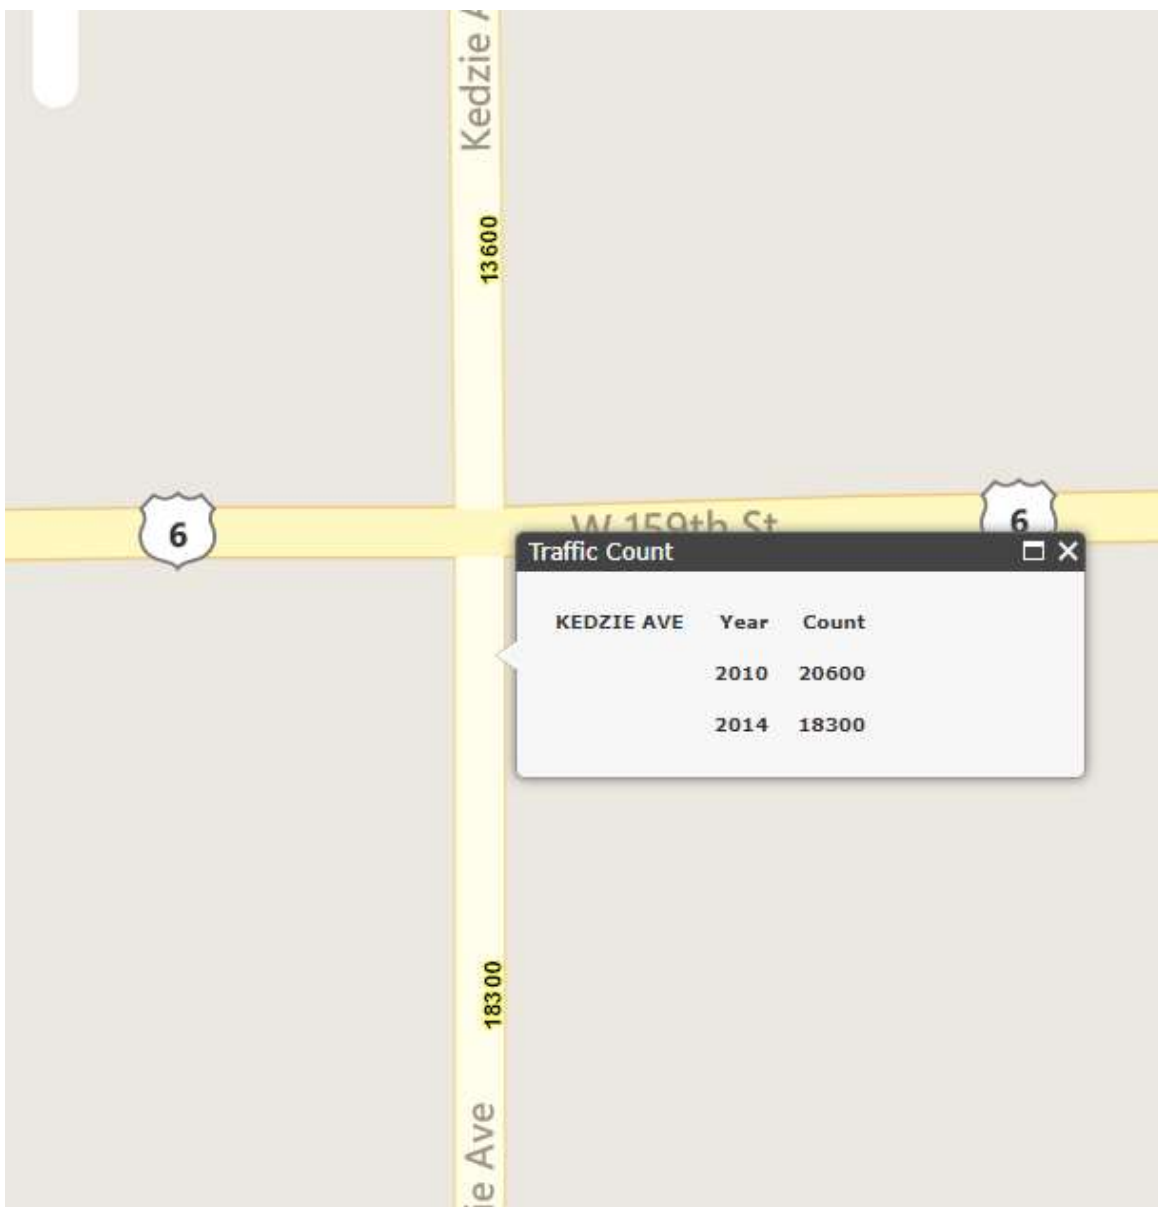
US Rte. 6 (159<sup>th</sup> Street) at Kedzie Avenue (Northbound)

- 20,600 (2010)
- 18,300 (2014)

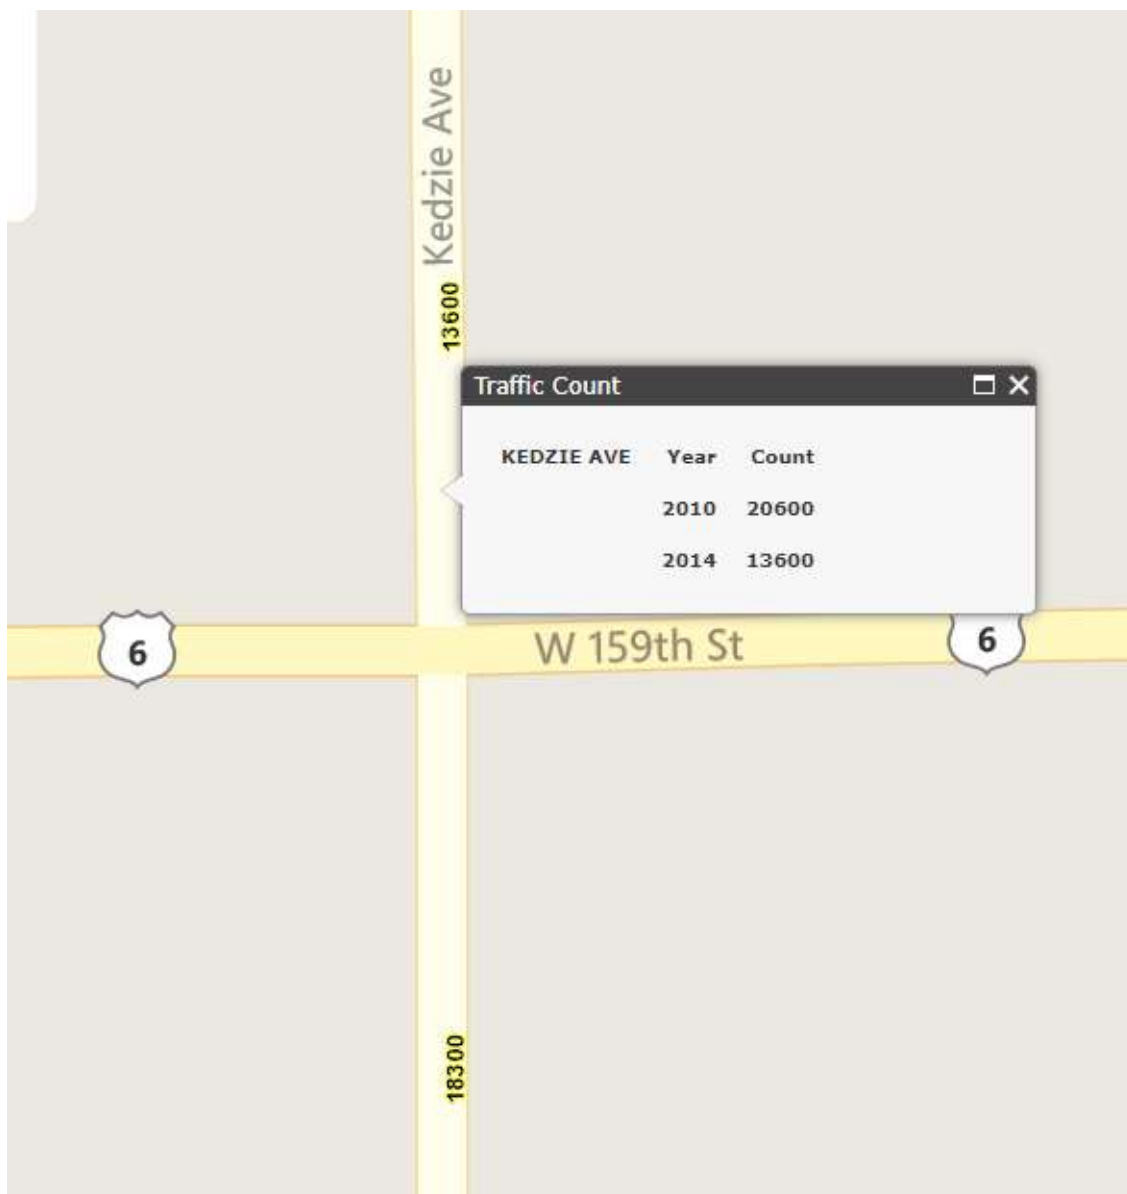
US Rte. 6 (159<sup>th</sup> Street) at Kedzie Avenue (Southbound)

- 20,600 (2010)
- 13,600 (2014)
